Calpine The Geysers, Middletown, CA – Cooling Tower Basin Concrete Rehabilitation Work & Combustion Chamber Reline – September 2008

Background

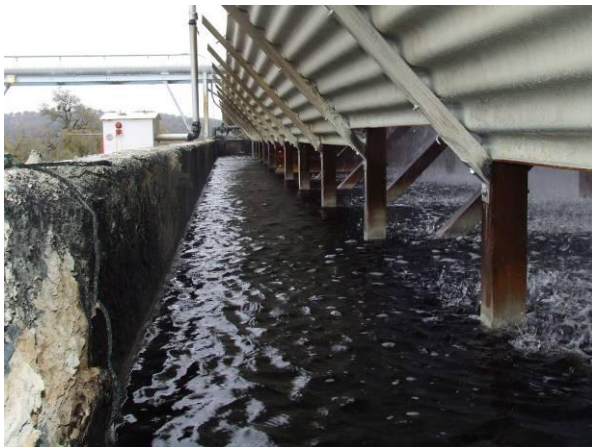
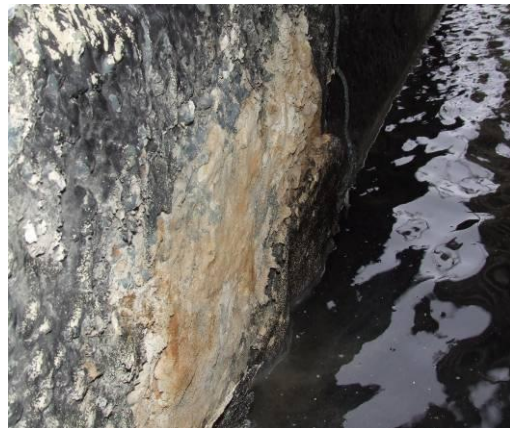
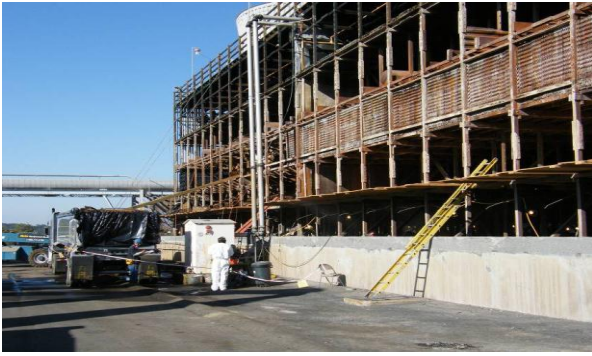
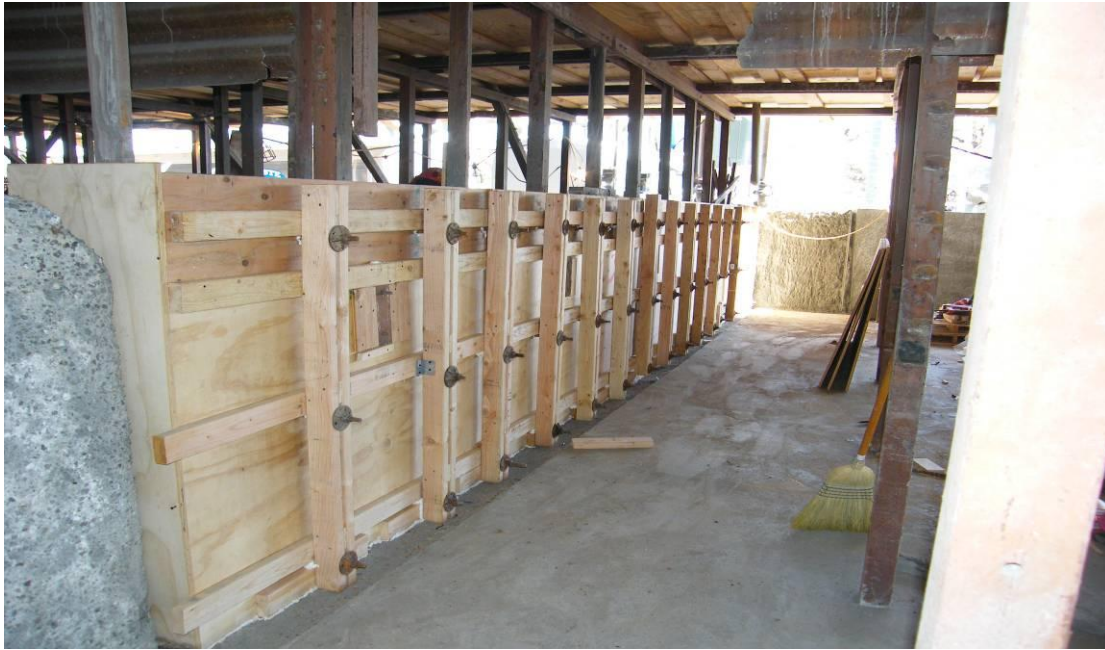
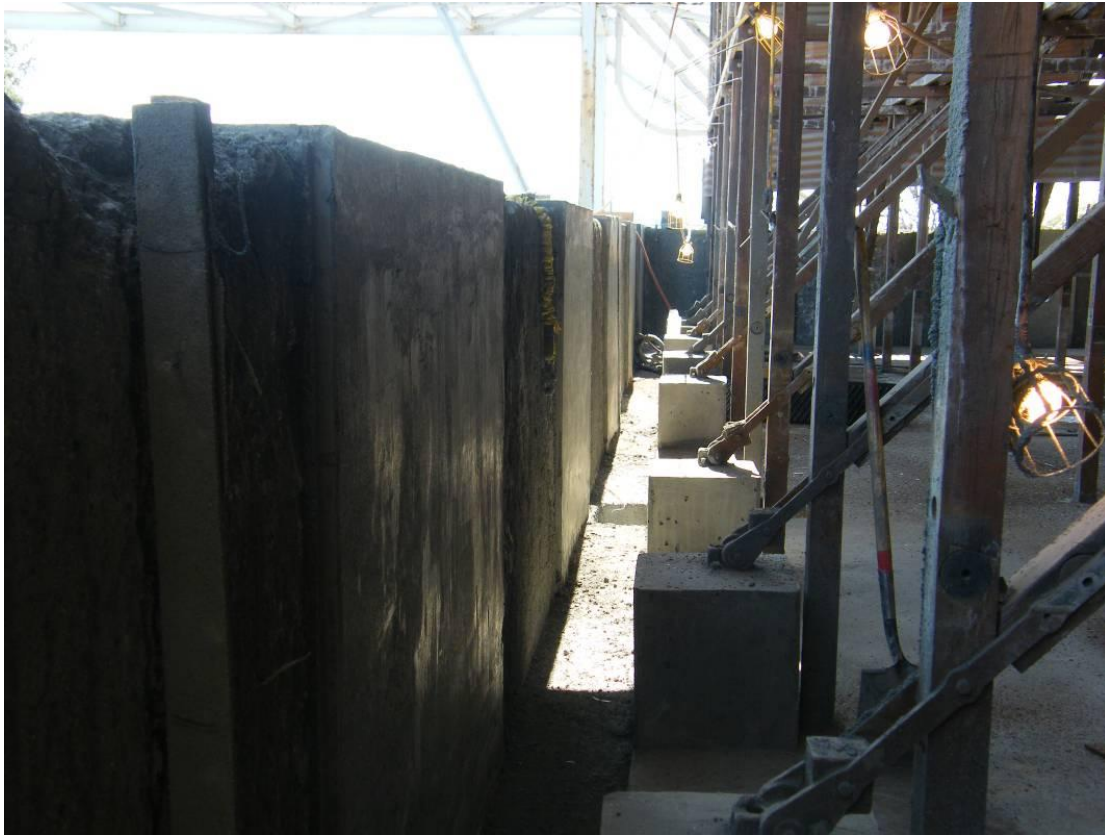
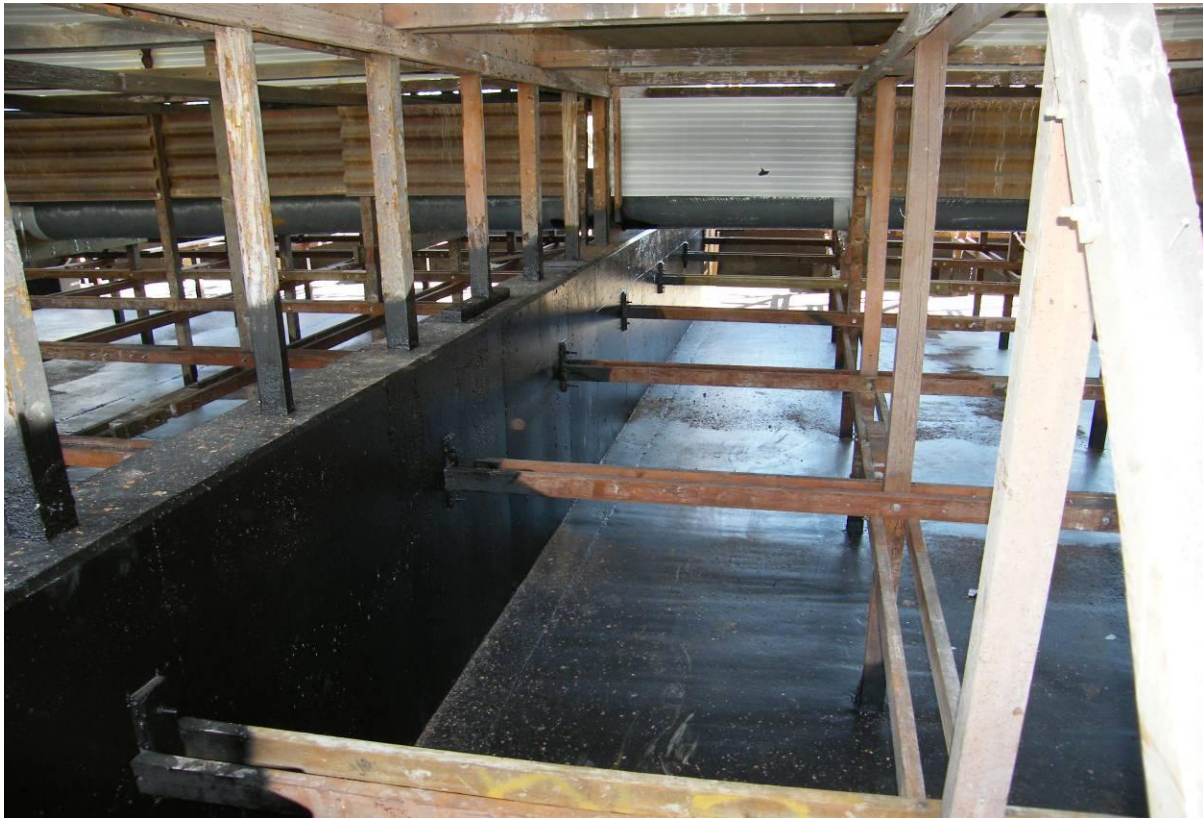
We have been looking at this Cooling Tower Basin Sidewall / Endwall / Partition Wall / Floor concrete rehabilitation job for the last year or so. We decided on a different material rather than an acid-resistant concrete type. The failure of the concrete in this basin was over-exposure to cooling tower water (composition of water is sulfur, mercury, arsenic, ammonia to name a few) over a 20-25 year period, where the existing concrete was showing a fast rate of deterioration mechanically and chemically. Therefore, our repair plan / recommendation was not only to install a corrosion proof overlayment over the existing concrete, but also to re-establish the structural integrity of the basin sidewalls / endwalls and partition wall. Also, we have used this same repair methodology for sulfur pit repairs, heat exchanger pedestal repairs, salt water pier supports/ columns.

Over the past 2 to 3 years, JTT has been successfully completing refractory reline work and repairs for a Cooling Tower Circulating Pump Pit at a geothermal power plant.
